### Complaint Against the Valuation of Real Property

# Home Inspection Report

7325 Heritage Rd  
Magnolia, Ohio 44643-9550

May 31, 2024

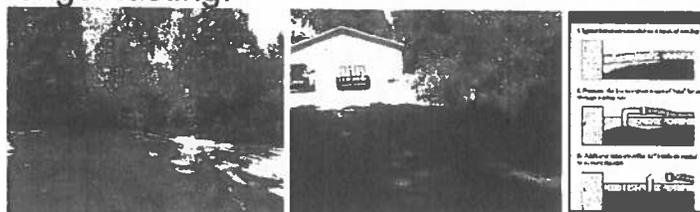
**Driveway:** concrete - The driveway concrete towards the road has settled quite a bit and slopes downward. Concrete leveling, commonly called mudjacking or polyjacking might be an option. Concrete leveling, or mudjacking is a process where holes are drilled through the concrete and a pressurized concrete slurry is pumped under the concrete slab, lifting the concrete. A newer method, called polyjacking, is to pump polyurethane foam under the concrete slab, which is thought to be longer lasting.

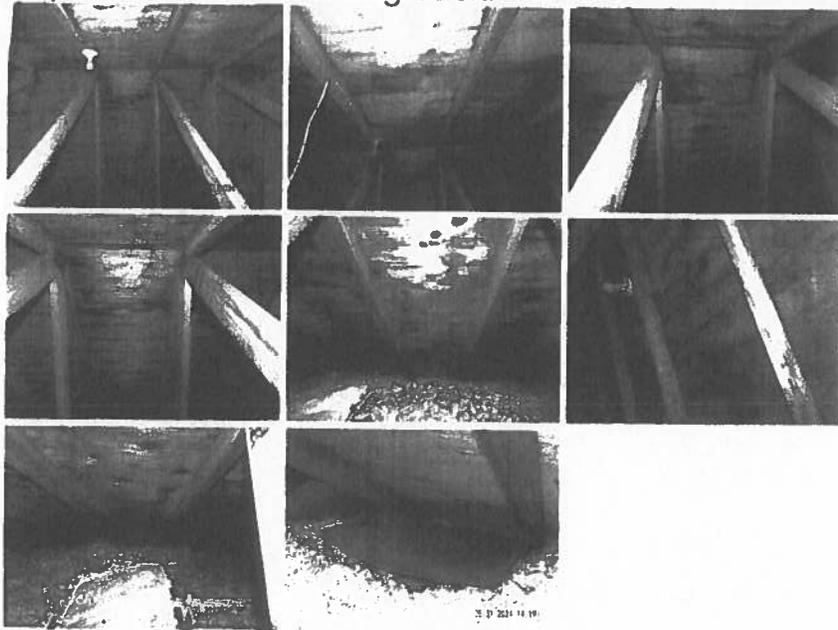
Mold can be a health and safety risk for many people. Some are affected more than others. People with compromised immune systems, lung diseases, and asthma are usually more susceptible. I recommend consulting a certified mold remediation contractor, but be aware that the source of excessive moisture must be cured, prior to mold remediation, to prevent it from coming back.

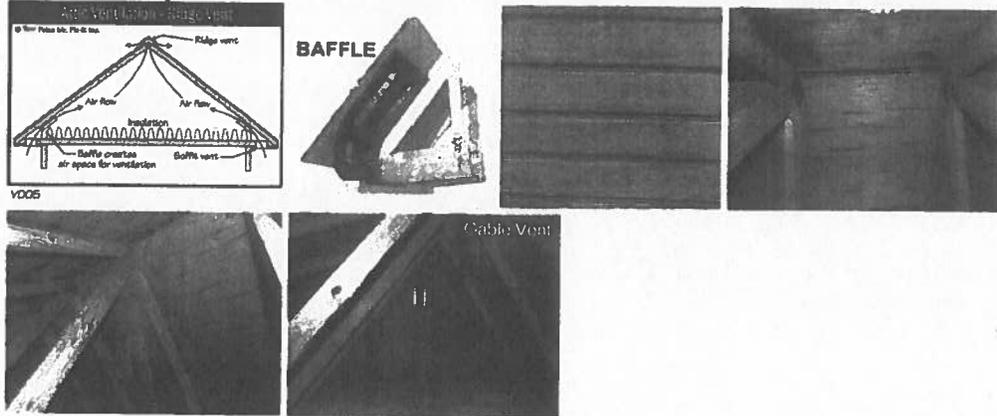
Ventilation: (continued)

**Ventilation:** There are minimal vented soffit vents in combination with ridge vent. - The ridge vent filter medium has fallen out and some is some hanging. This is likely from previous ridge vent. The ridge vent is exhaust vent. There are gable vents which are considered a type of exhaust vent. It is not recommended to mix multiple types of exhaust vents in an attic. It could short circuit the soffit to ridge vent air flow from low to high. I recommend covering it from inside the attic. Minimum attic ventilation is one square foot of ventilation for every 150 square foot of attic area, ideally with 50% intake and 50% exhaust vents or 60% lower roof intake vents in combination with 40% upper exhaust vents. See more comments that apply under "Sheathing" in this attic section.

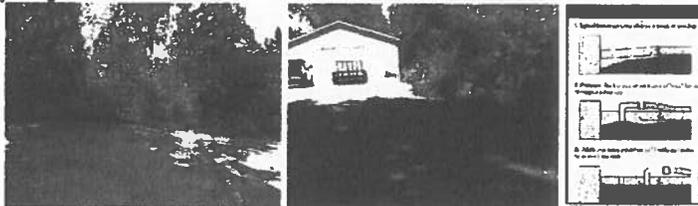
1. **Driveway:** concrete - The driveway concrete towards the road has settled quite a bit and slopes downward. Concrete leveling, commonly called mudjacking or polyjacking might be an option. Concrete leveling, or mudjacking is a process where holes are drilled through the concrete and a pressurized concrete slurry is pumped under the concrete slab, lifting the concrete. A newer method, called polyjacking, is to pump polyurethane foam under the concrete slab, which is thought to be longer lasting.

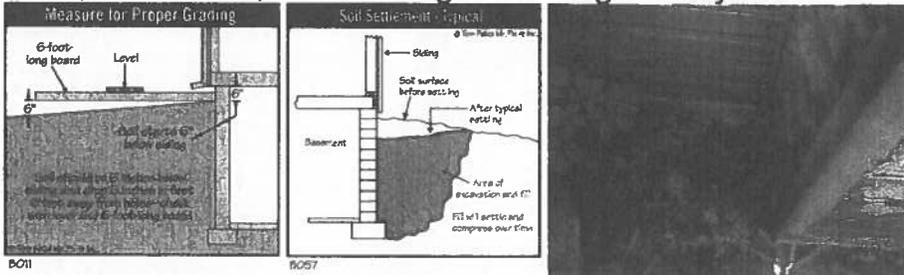
2. **Grading:** The grading slope at the foundation is mostly concealed by vegetation. There is some low negative grade at the west side chimney chase. It's mostly flat on the west side. Re-grading, or adding and compacting soil at the foundation, to create more slope away from the structure, could improve, or prevent, moisture problems in basement walls, as well as, maintaining the rain gutter system.

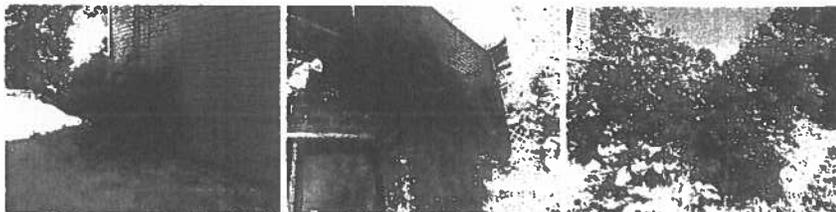
3. **Vegetation:** Trees, shrubs, and plants - I recommend removing the ivy growing on the vinyl siding. It will grow behind the vinyl siding, as well. Ivy can cause damage and it can promote insect and rodent infestation and moisture intrusion. I recommend maintaining all vegetation 12 inches from the house to help prevent wood destroying insect intrusion.

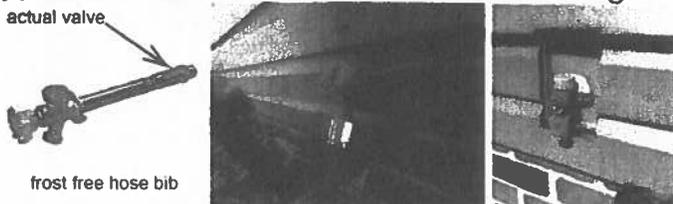
- 6. Hose Bibs:** There is a hose bib (spigot) on the west side. It is not a frost free type and must be turned off in the basement for the winter to prevent frozen burst water pipes that could cause costly water damage. I was unable to remove the hose. There is a frost free hose bib (spigot) with an anti-siphon vacuum breaker on the east side. The handle is missing and it was not tested. Replace the missing handle. All hoses on all types of hose bibs need removed during the winter to prevent costly water damage.

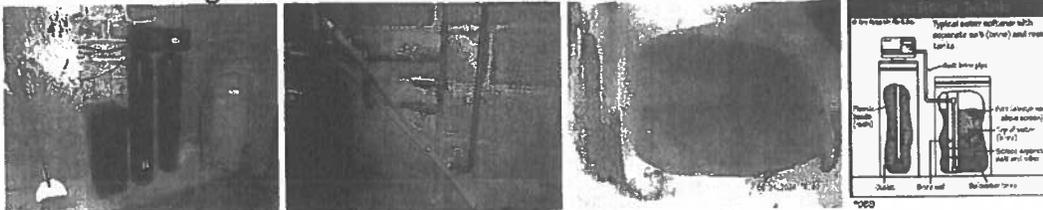
25. Water Conditioning Equipment: There is a two tank water softener and a tank that aerates the water. It is supposed to remove iron from the water, however, the water in the jetted spa tub was brown. Water softeners and other water treatment devices are outside the scope of this home inspection. Functionality cannot be determined. The third tank reportedly aerates the water, which is a natural technique to remove dissolved iron from water, without the use of additional chemicals. It can also remove dissolved manganese to some extent.

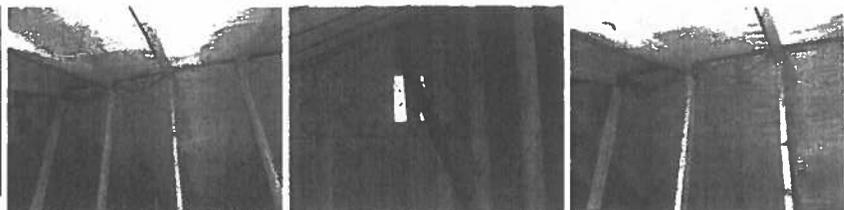
- 34. **attached garage and the northeast first floor house Attic Ventilation:** soffit vents in combination with ridge vent. The ridge vent filter medium has fallen out and some is some hanging. This is likely from previous ridge vent. The ridge vent is exhaust vent. There is a gable vent which is considered a type of exhaust vent. It is not recommended to mix multiple types of exhaust vents in an attic. It could short circuit the soffit to ridge vent air flow from low to high. I recommend covering it from inside the attic.

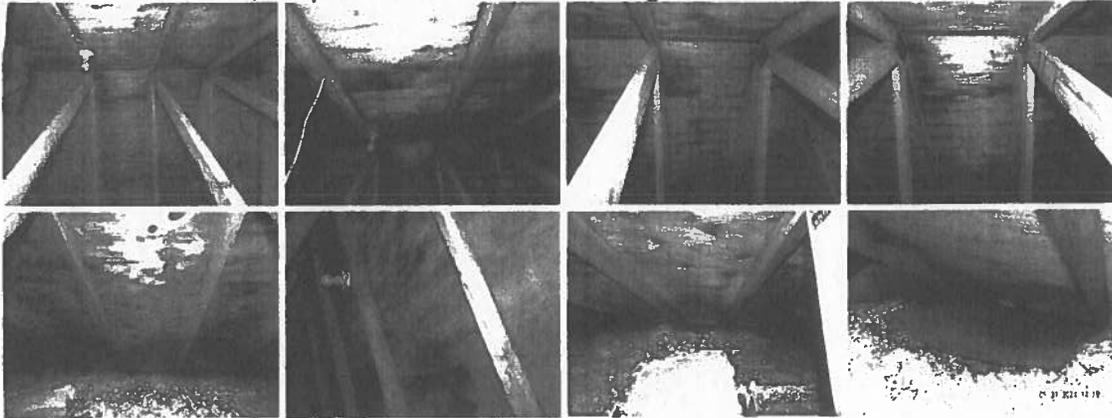
Mold can be a health and safety risk for many people. Some are affected more than others. People with compromised immune systems, lung diseases, and asthma are usually more susceptible. I recommend consulting a certified mold remediation contractor, but be aware that the source of excessive moisture must be cured, prior to mold remediation, to prevent it from coming back.

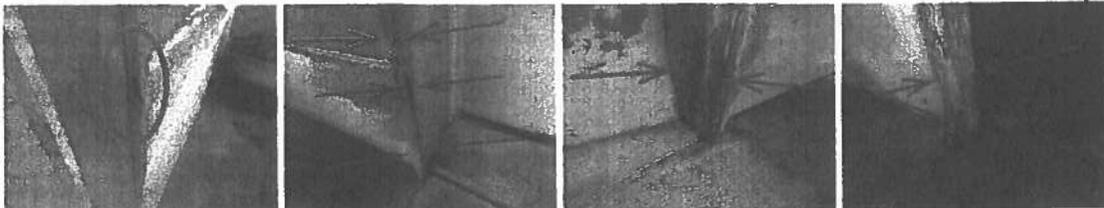
- 3. east Outbuilding Trim:** vinyl and wood - The wood trim around the exterior man door needs painted to prevent wood rot. Vinyl siding corner channel at the bottom of the overhead door is cracked and broken on both sides and should be replaced.

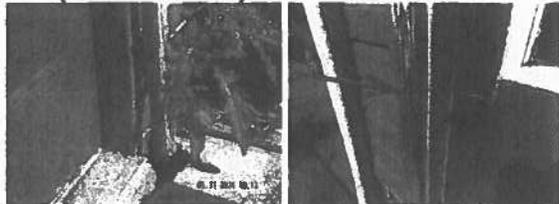
Trim: (continued)

- 4. Attached Garage Trim:** vinyl and wood - The wood trim around the exterior man door is pulling away from the door frame and needs repaired or replaced. The wood casing and trim needs painted to prevent wood rot.

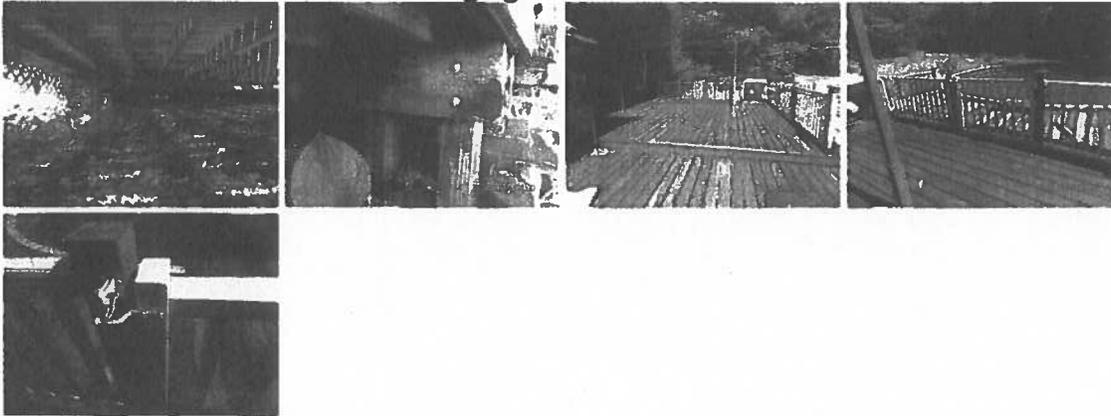
- 2. Deck:** pressure treated lumber - The deck is free standing and does not rely on attachment to house structure. This is good. The guard rail vertical balusters are spaced wider than is currently required. A four inch sphere should not be able to pass between them. This has been required before this deck was built. The section of vinyl guard rail at the pool moves when tested. It should be able to withstand 200 pounds of lateral force without moving. The gate in that section of vinyl guard rail drops and needs lifted a little for the latch to engage.

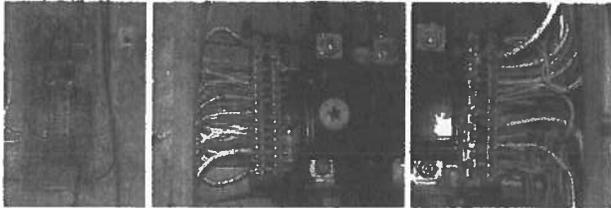
This is very common, and has historically been misinterpreted, but has never been an accepted practice. It was clarified in the 2008 NEC 408.21 (National Electric Code). Prior to that, it has always not been allowed per manufactures installation instructions, and the National Electric Code has always recommended following manufacturer's installation instructions. Additional bus bars may need installed.

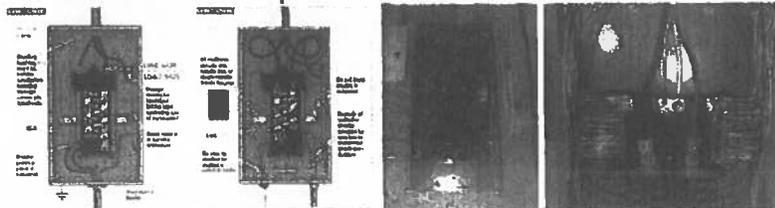
**13. basement left Electric Panel Panel Integrity:** Grounds and neutrals need isolated to provide separate paths back to the source. This was required prior to 2008 for panels in the same building, and is currently required. This has a four wire feed, Two hots, a neutral, and a ground. For clarity, the bare copper ground wires must be connected to a separate bus bar than the white neutral conductors (wires). The white neutral conductors must be connected to a bus with only white neutral conductors and there can be only one wire connected to each terminal. It also currently has multiple white neutral conductors per terminal connection, which is wrong, and was never an acceptable practice, but can be corrected when the neutrals and grounds are isolated. The green bonding screw also needs removed. I recommend that a qualified licensed electrician make repairs.
