RE: Letter of Notifications  
Blackbird 138kV Extension Project, Case No. 26-0534-EL-BLN and  
Tidd-Sunnyside 138kV Cut-in and Krone 138kV Switch Project, Case No. 26-0535-EL-BLN

- Blackbird 138kV Extension Project, Case No. 26-0534-EL-BLN
  - Construct less than .1 miles of 138-kilovolt (kV) power line to provide permanent service to a customer's facility.
- Tidd-Sunnyside 138kV Cut-in and Krone 138kV Switch Project, Case No. 26-0535-EL BLN
  - Install a switch pole and construct less than .1 miles of 138-kilovolt (kV) power line extending from the Tidd-Sunnyside 138-kV transmission line to the switch pole.

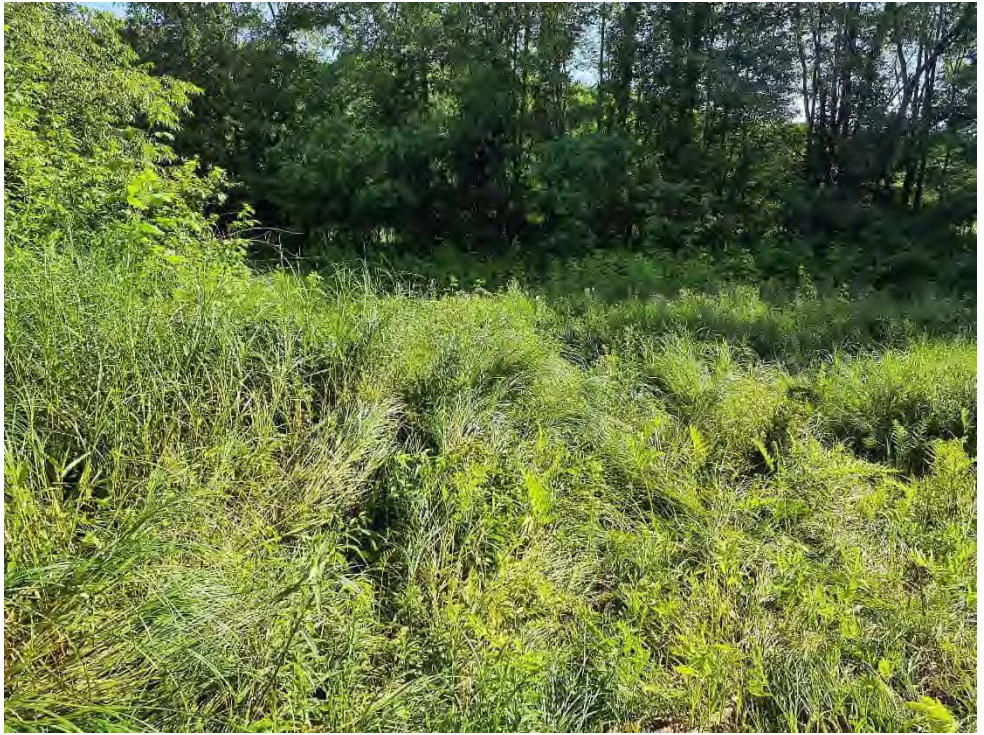
| <b>W-AGS-001</b> | |

| <b>Description:</b><br><br>PEM Wetland<br><br>Category 2<br><br>Facing North | |

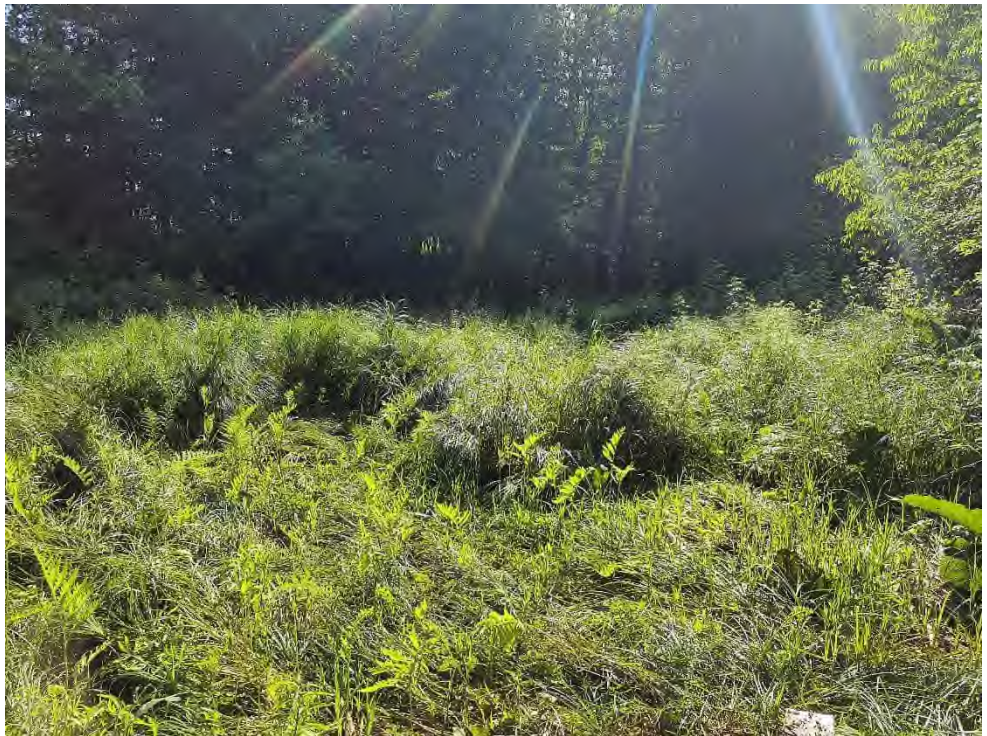
| <b>W-AGS-001</b> | |

| <b>Description:</b><br><br>PEM Wetland<br><br>Category 2<br><br>Facing East | |

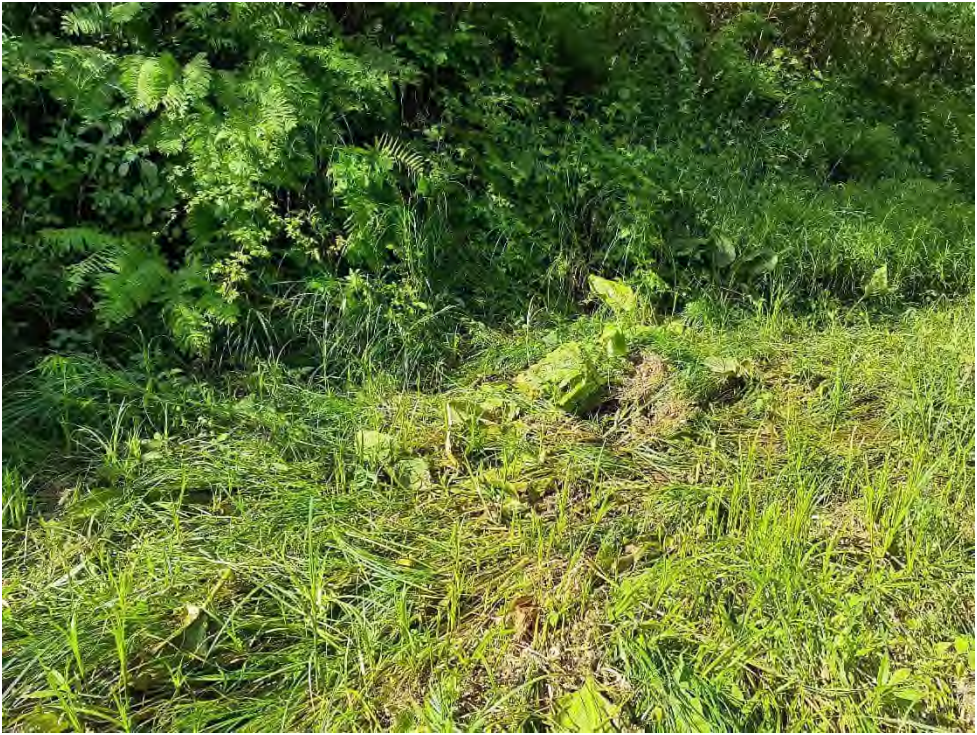
| <b>W-AGS-001</b> | |

| <b>Description:</b><br><br>PEM Wetland<br><br>Category 2<br><br>Facing South | |

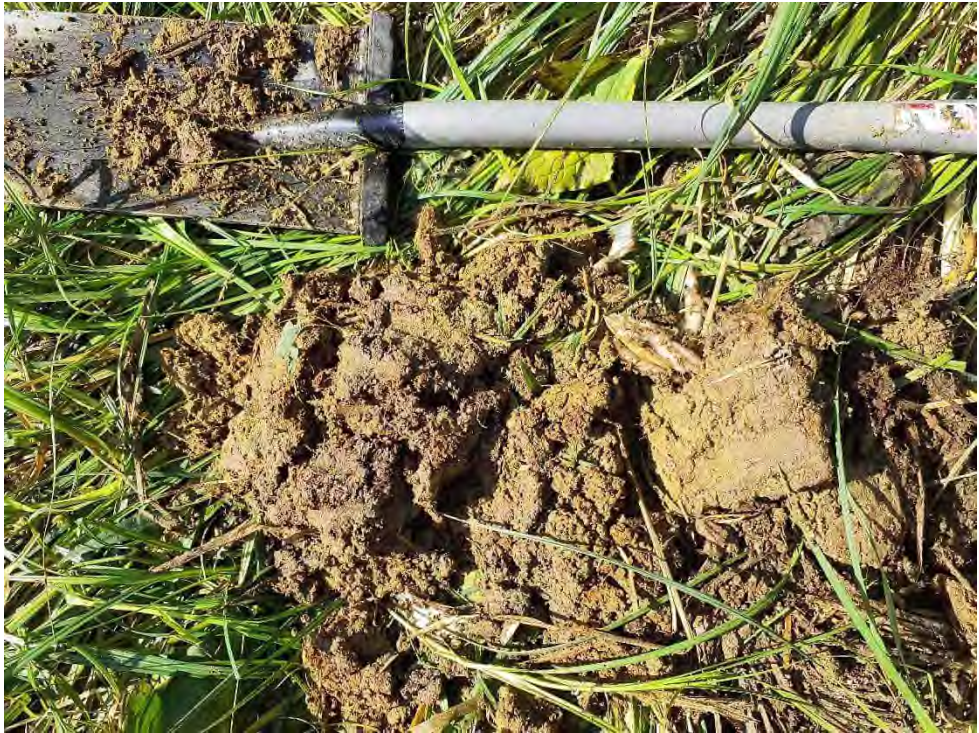
| <b>W-AGS-001</b> | |

| <b>Description:</b><br>PEM Wetland<br>Category 2<br>Facing Soil | |

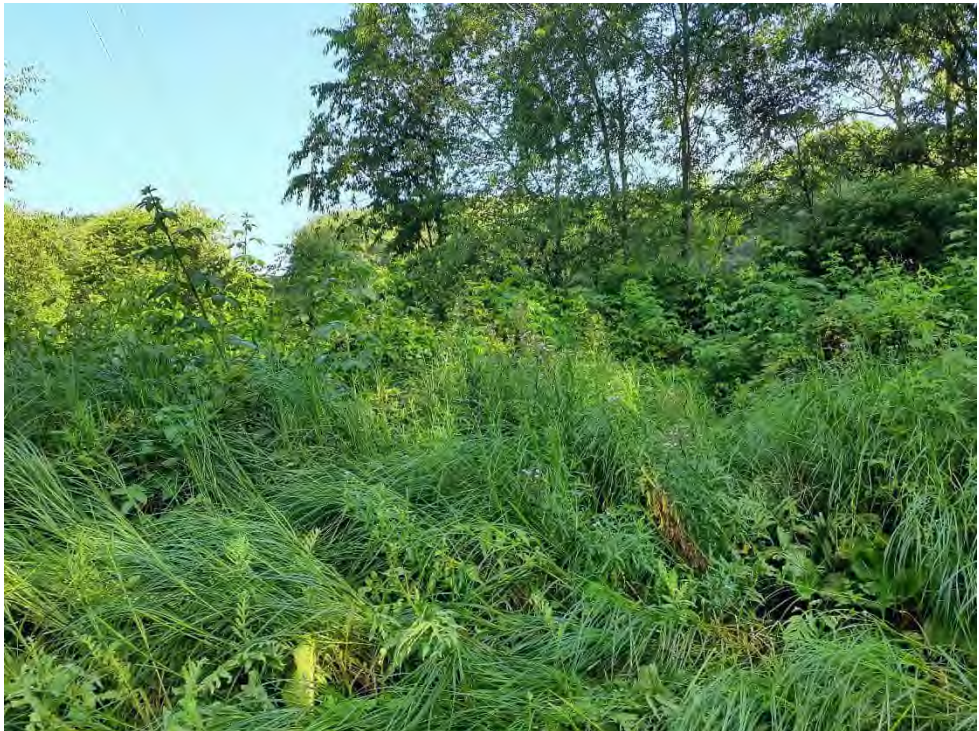
| <b>W-AGS-001</b> | |

| <b>Description:</b><br>PSS Wetland<br>Category 2<br>Facing North | |

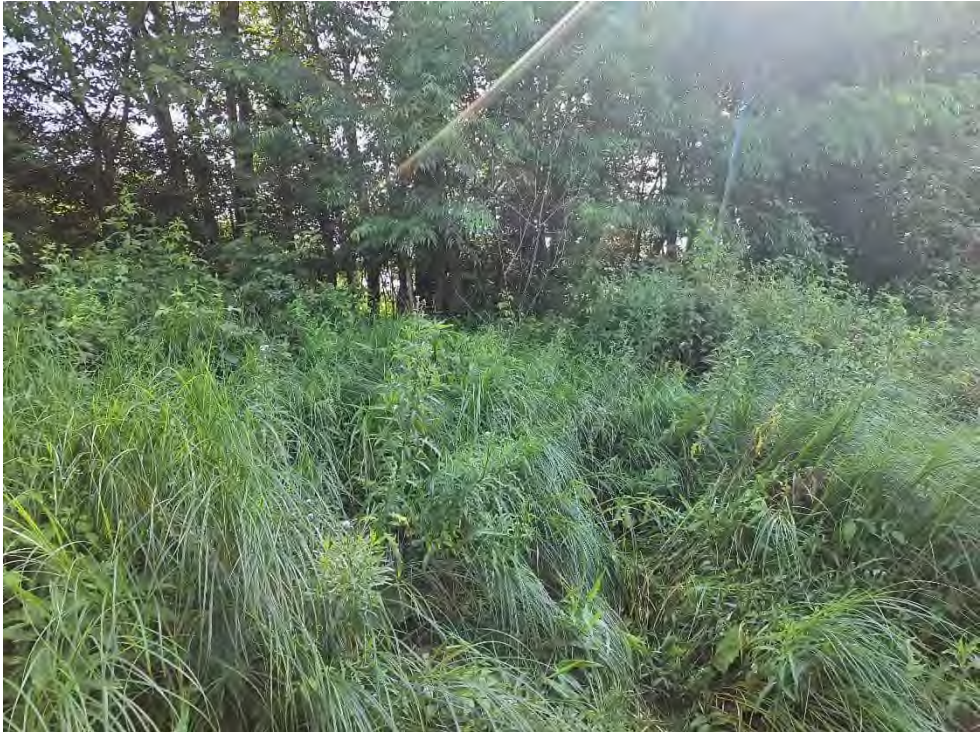
| <b>W-AGS-001</b> | |

| <b>Description:</b><br><br>PSS Wetland<br><br>Category 2<br><br>Facing East | |

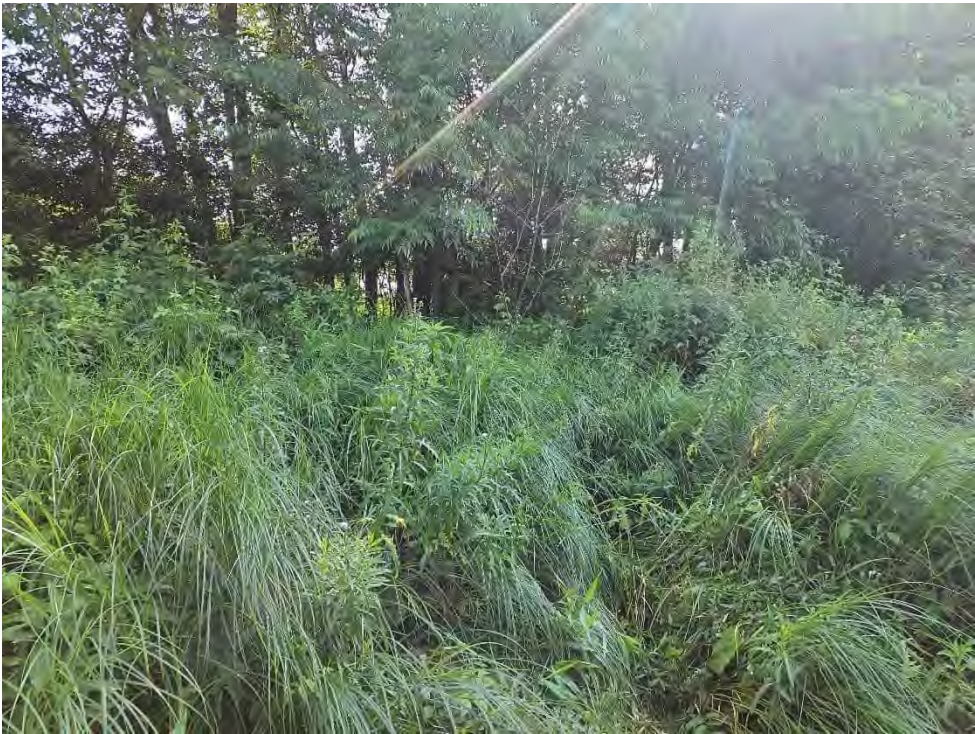
| <b>W-AGS-001</b> | |

| <b>Description:</b><br><br>PSS Wetland<br><br>Category 2<br><br>Facing South | |

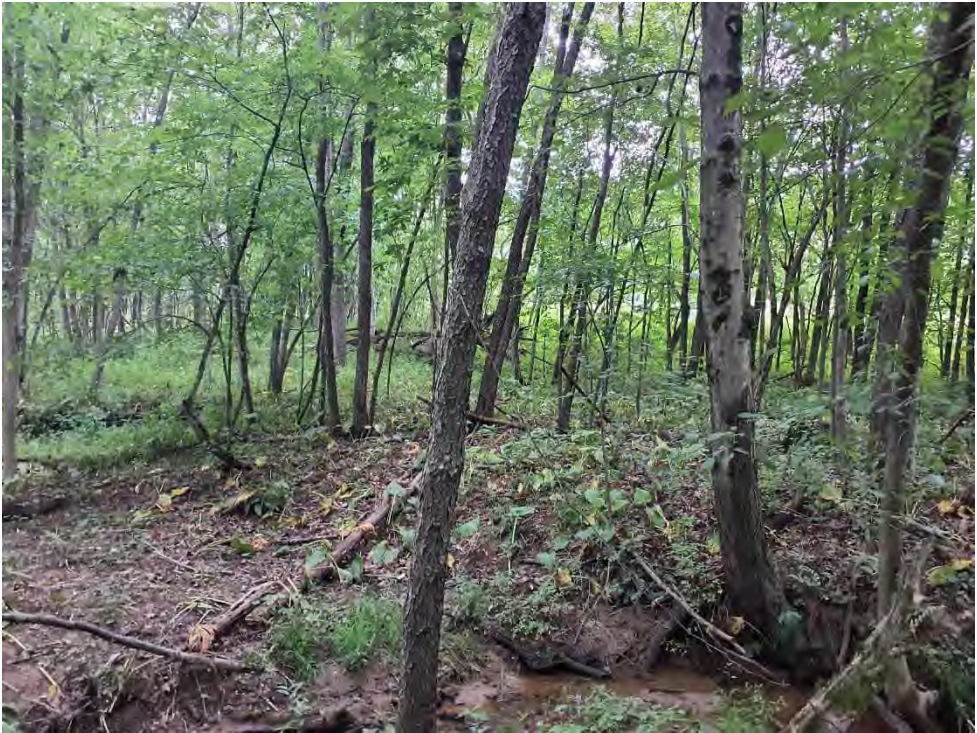
| <b>W-AGS-001</b> | |

| <b>Description:</b><br><br>PFO Wetland<br><br>Category 2<br><br>Facing North | |

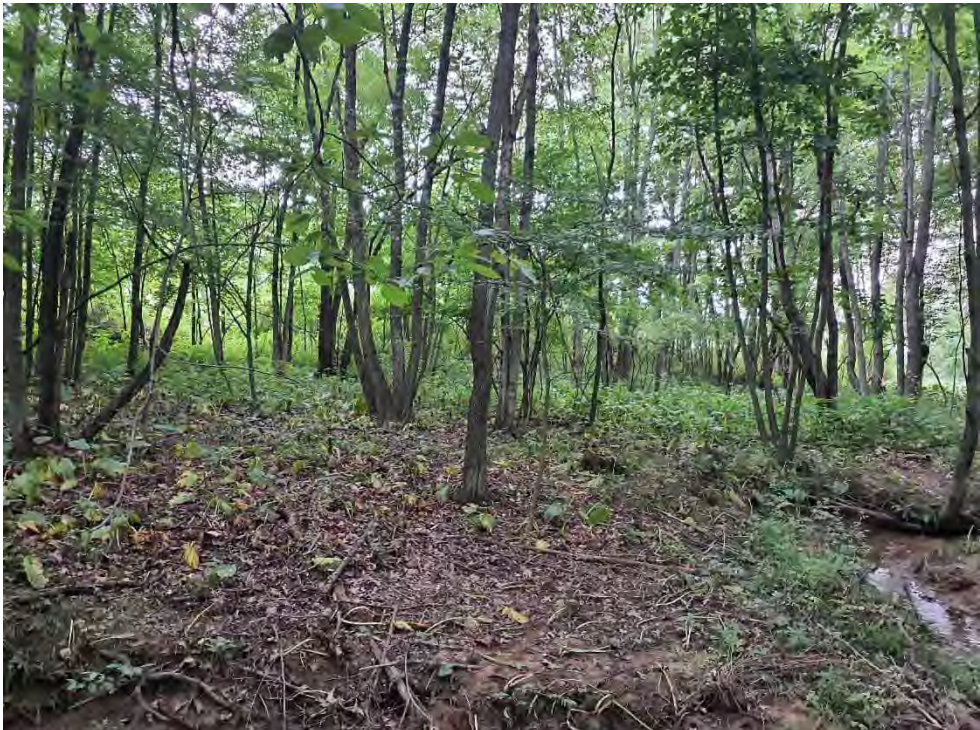
| <b>W-AGS-001</b> | |

| <b>Description:</b><br><br>PFO Wetland<br><br>Category 2<br><br>Facing East | |

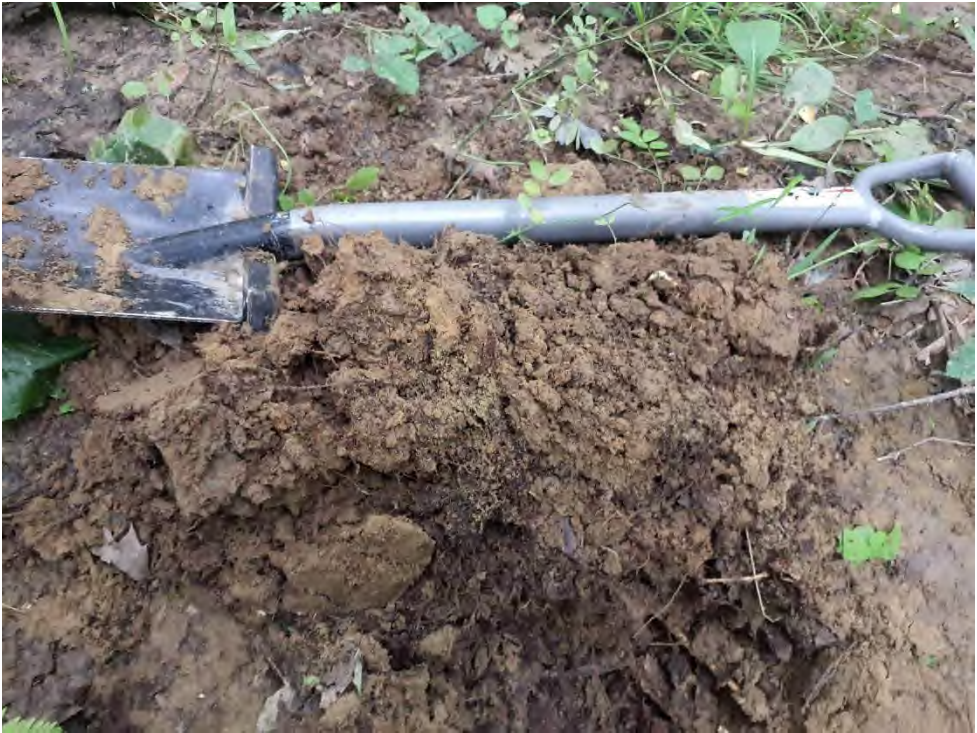
| <b>W-AGS-001</b> | |

| <b>Description:</b><br>PFO Wetland<br>Category 2<br>Facing Soil | |

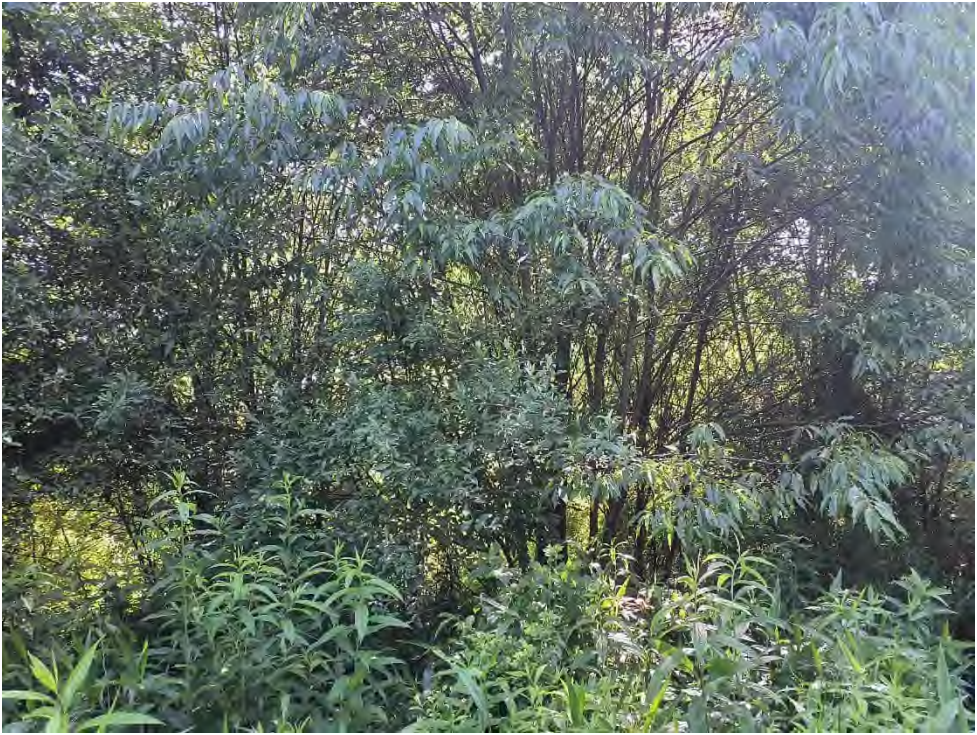
| <b>W-AGS-001-UPL</b> | |

| <b>Description:</b><br>Upland Datapoint<br>Facing East | |

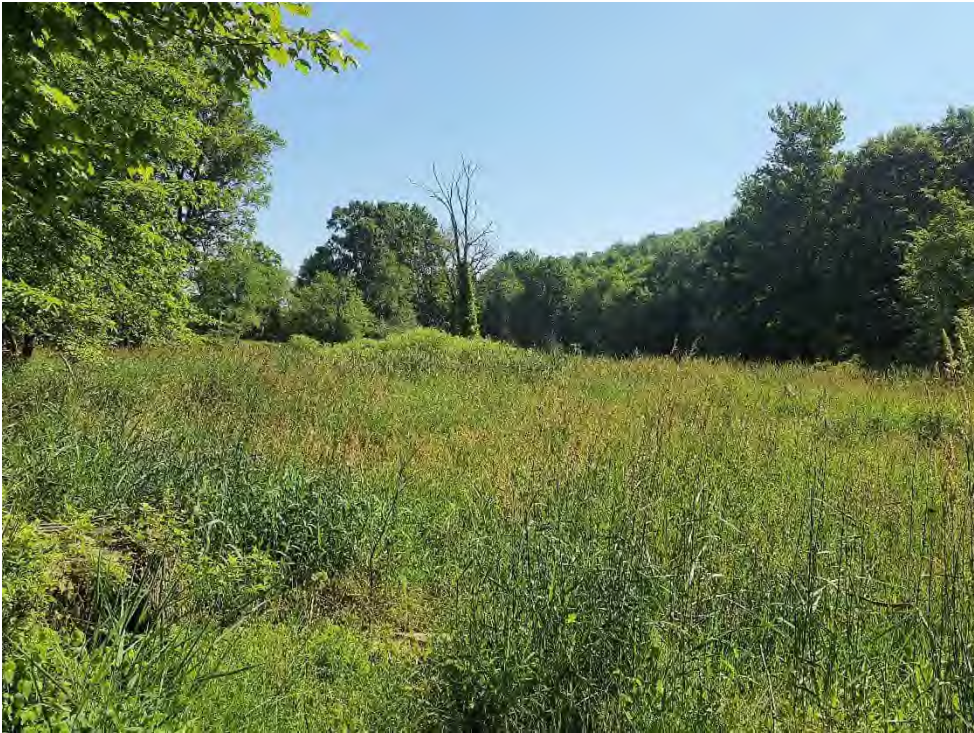
| <b>W-AGS-002</b> | |

| <b>Description:</b><br><br>PEM Wetland<br><br>Category 2<br><br>Facing North | |

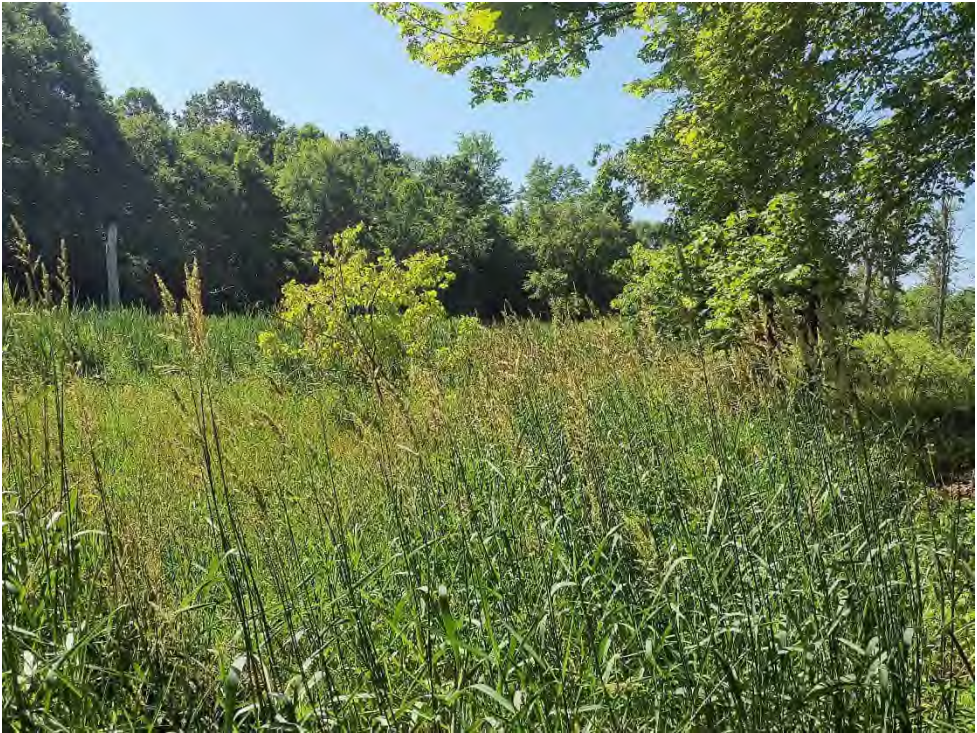
| <b>W-AGS-002</b> | |

| <b>Description:</b><br><br>PEM Wetland<br><br>Category 2<br><br>Facing South | |

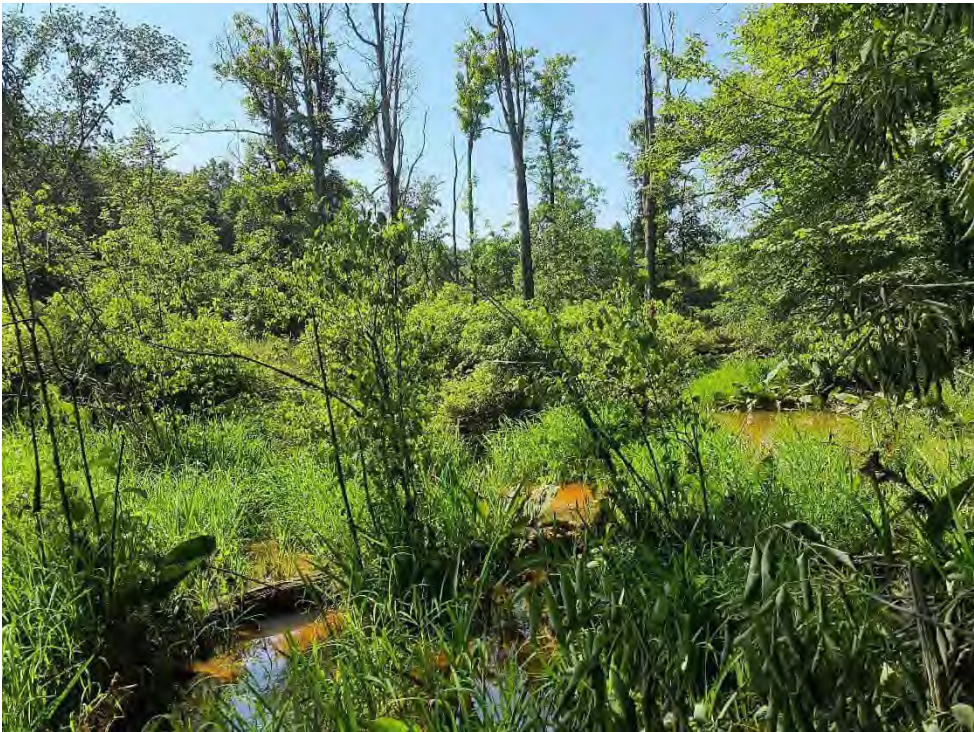
| <b>W-AGS-002</b> | |

| <b>Description:</b><br><br>PSS Wetland<br><br>Category 2<br><br>Facing South | |

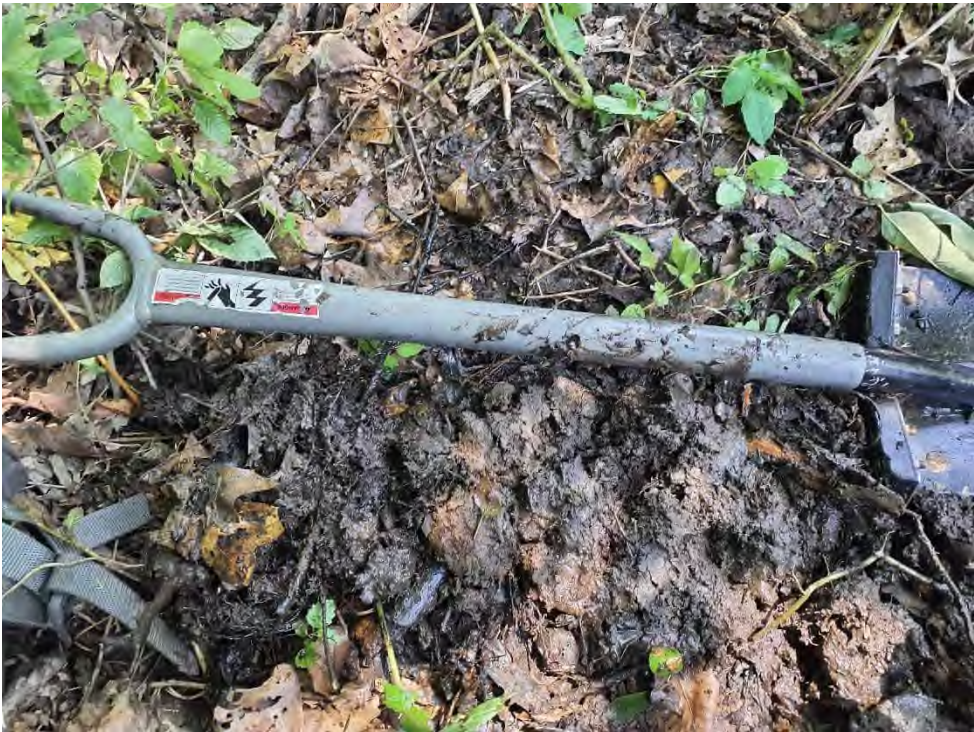
| <b>W-AGS-002</b> | |

| <b>Description:</b><br><br>PSS Wetland<br><br>Category 2<br><br>Facing Soil | |

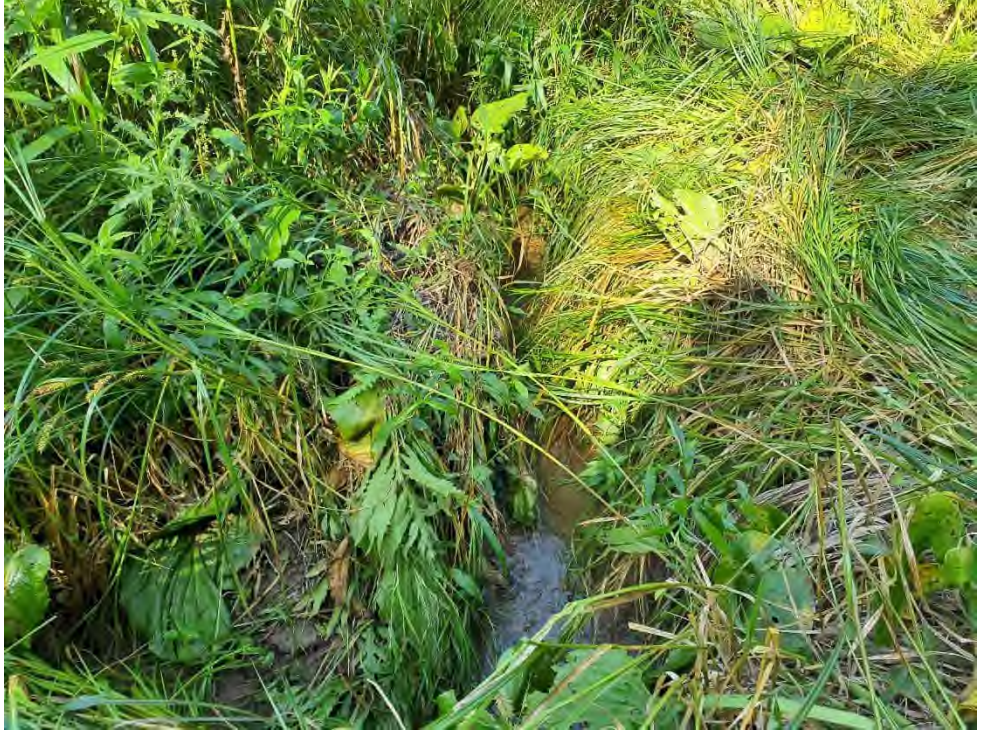
| <b>S-AGS-001</b> | |

| <b>Description:</b><br><br>Perennial<br><br>HHEI Assessment<br>Point 1<br><br>Facing Upstream | |

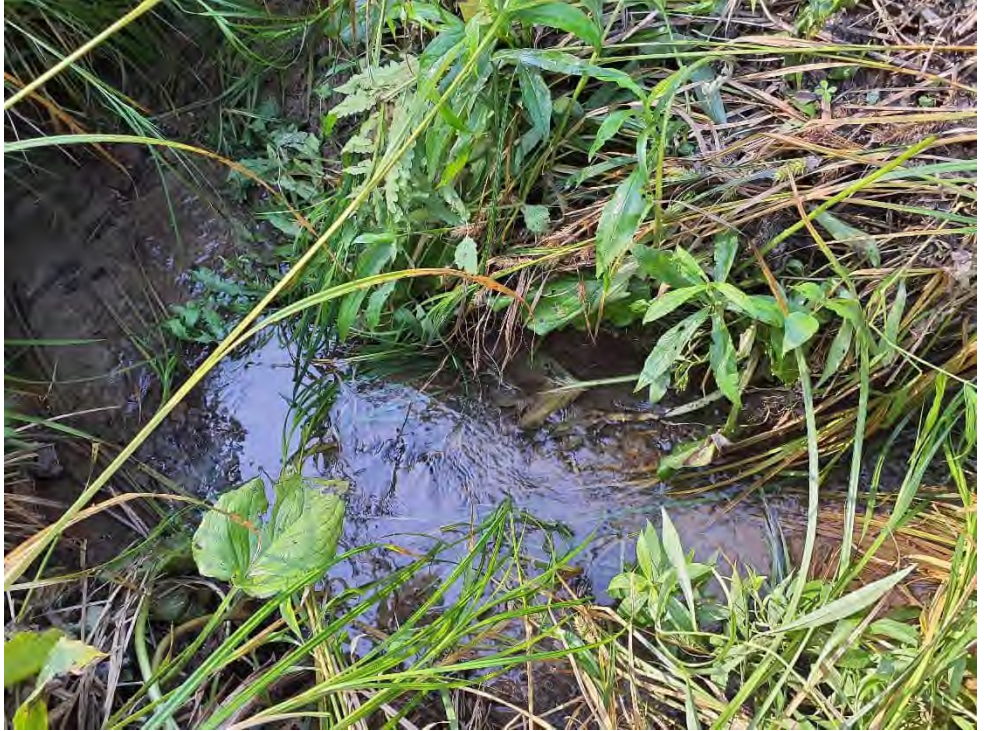
| <b>S-AGS-001</b> | |

| <b>Description:</b><br><br>Perennial<br><br>HHEI Assessment<br>Point 1<br><br>Facing Substrate | |

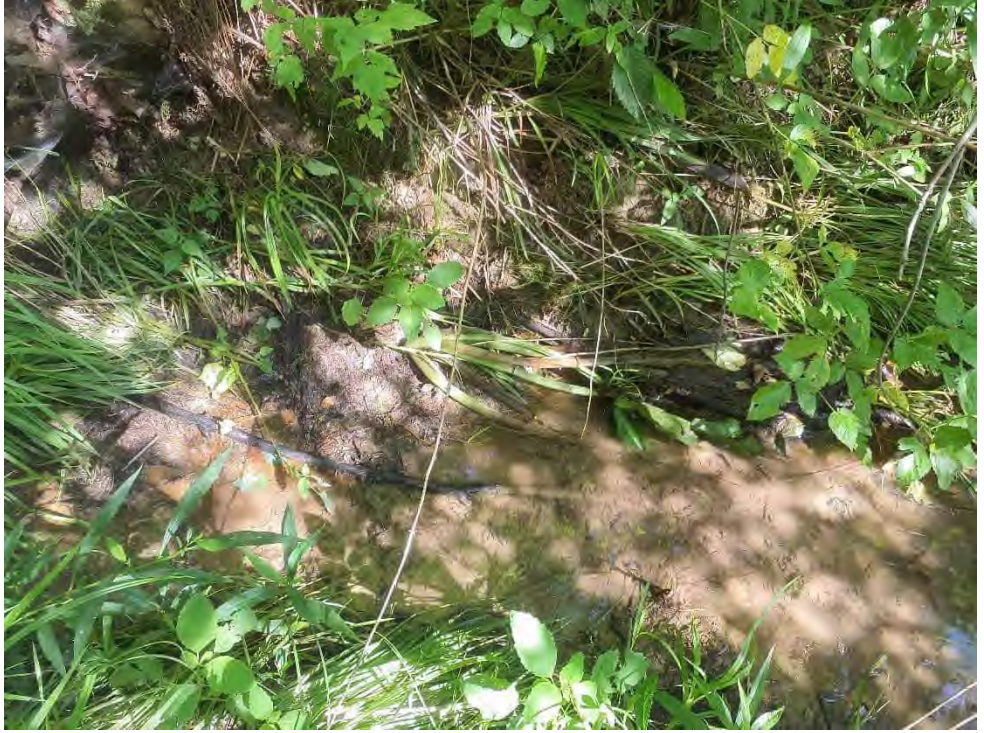
| <b>Description:</b><br><br>Intermittent<br><br>Facing Substrate | |

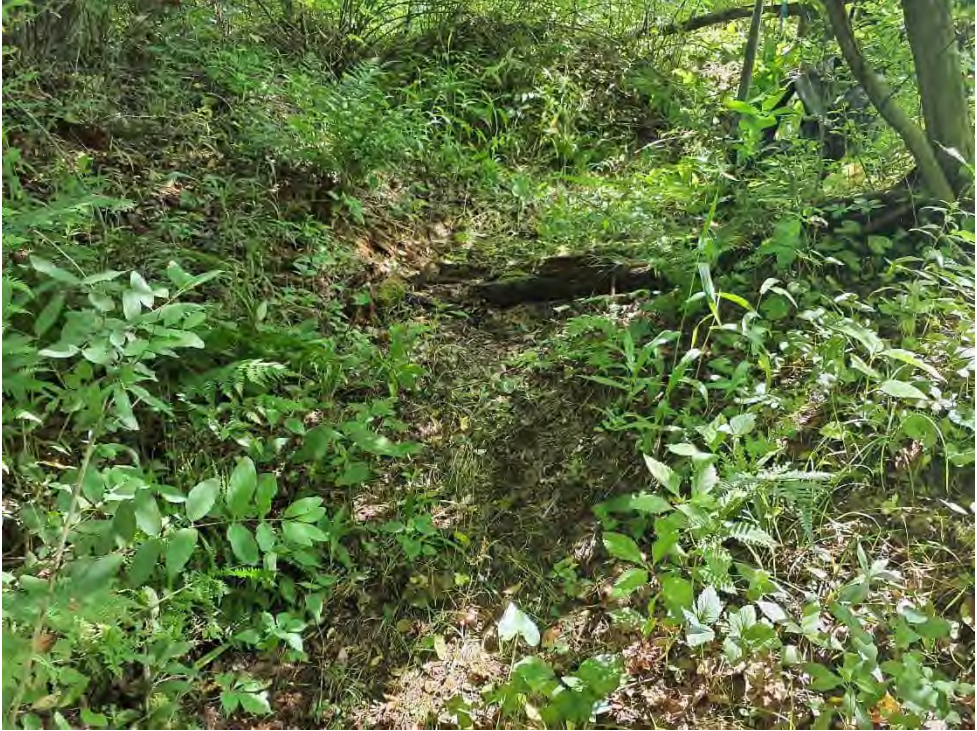
| <b>S-AGS-003</b> | |

| <b>Description:</b><br>Ephemeral<br>Facing Downstream | |

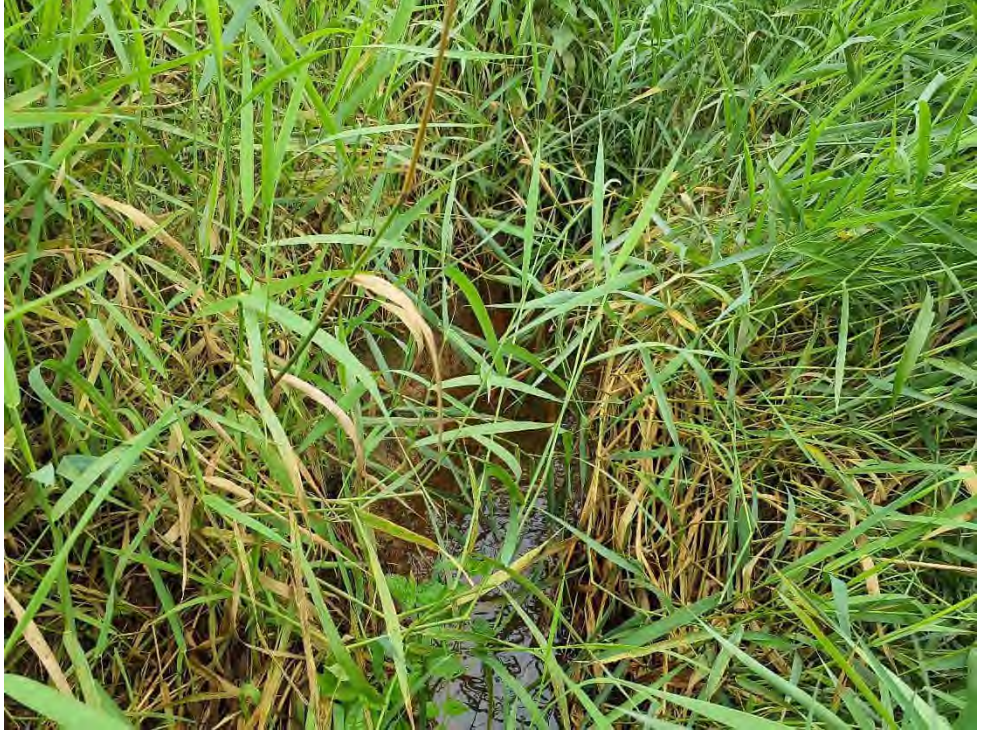
| <b>S-AGS-004</b> | |

| <b>Description:</b><br><br>Perennial<br><br>Facing Upstream | |

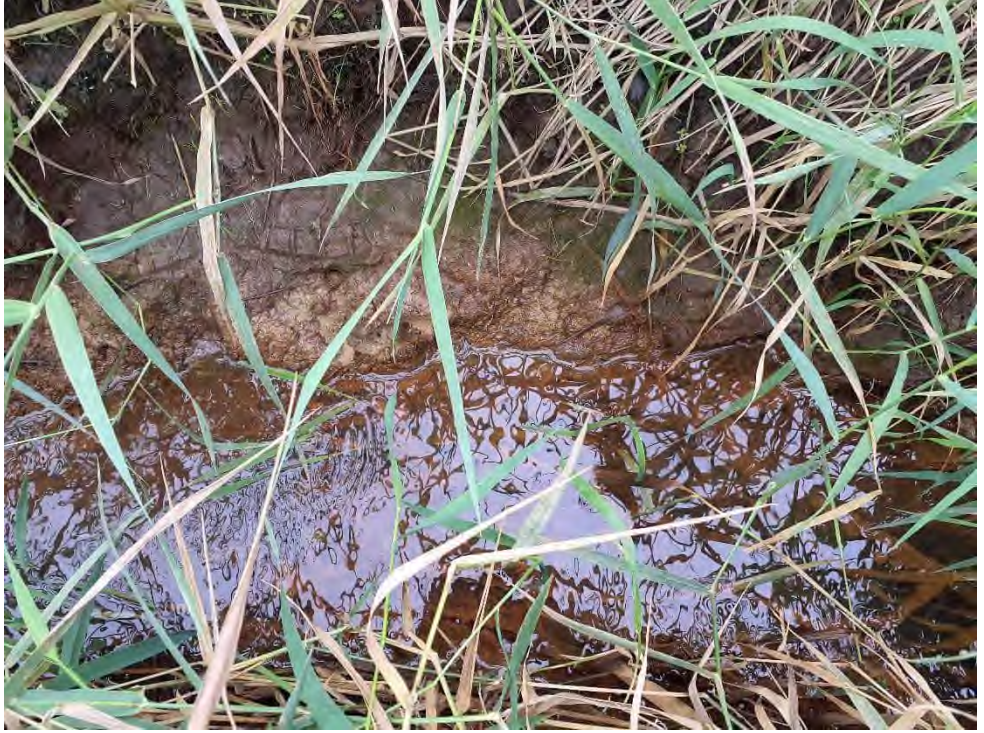
| <b>S-AGS-004</b> | |

| <b>Description:</b><br>Perennial<br>Facing Substrate | |

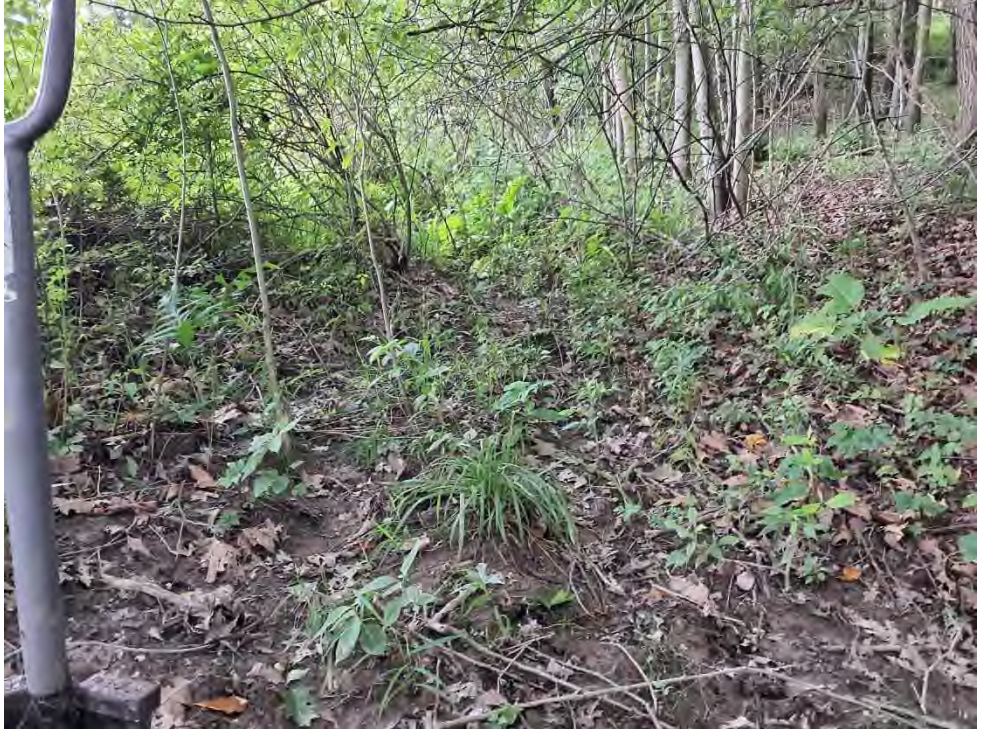
| <b>UDF-AGS-001</b> | |

| <b>Description:</b><br><br>Upland Drainage<br>Feature<br><br>Facing Upgradient | |
